FOUNDATIONS

UNSEEN, BUT FUNDAMENTAL TO ALL CONSTRUCTION

By PETER CONSTANTINE

6 November 2025

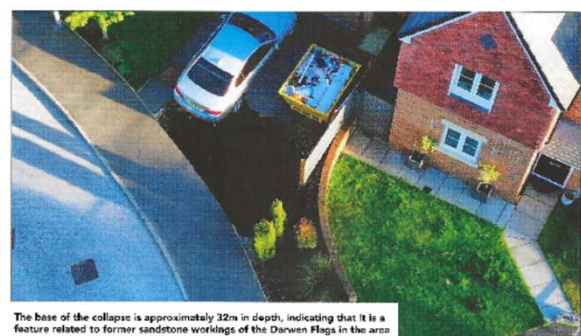
The base of the collapse is approximately 32m in depth, indicating that it is a feature related to former sandstone workings of the Darwen Flags in the area

But the authority later said that "extensive ground investigations" had found that the sinkhole was not caused by historical coal mining. The depth of the collapse and area that it is related to a former sandstone mine.

It said: "Based on the records from our ground investigations at Cecce, Fields, Darwen, we have found that the base of the collapse is approximately 32m in depth.

to former sandstone workings of the Darwen Flags in the area, considering deep records from historical investigations."

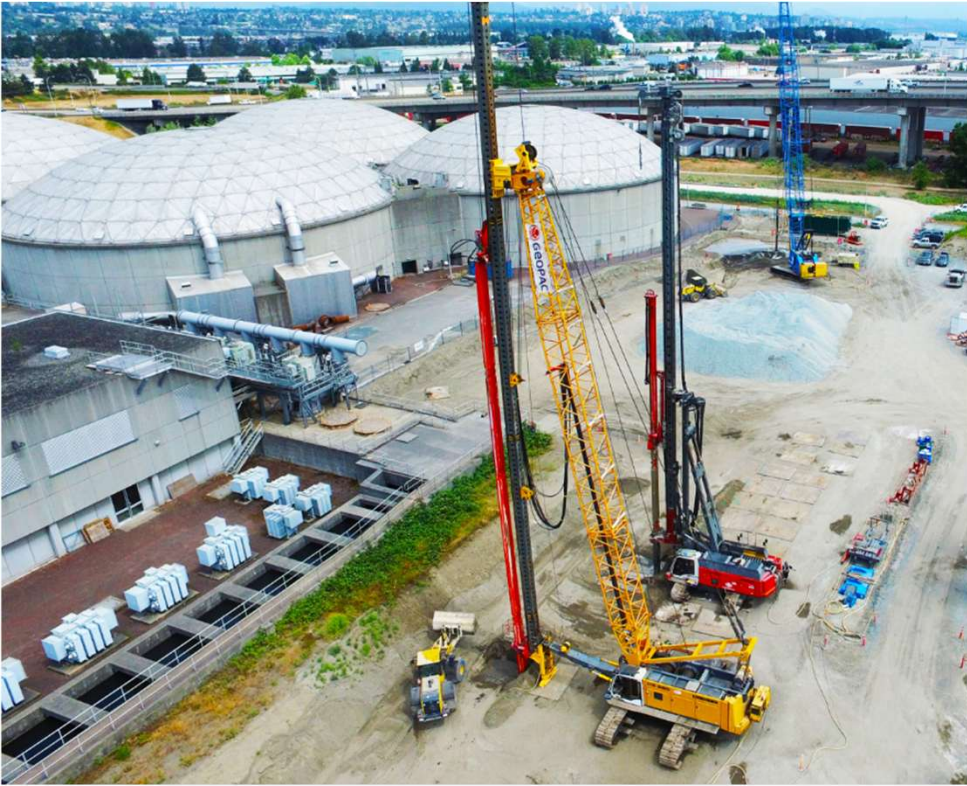
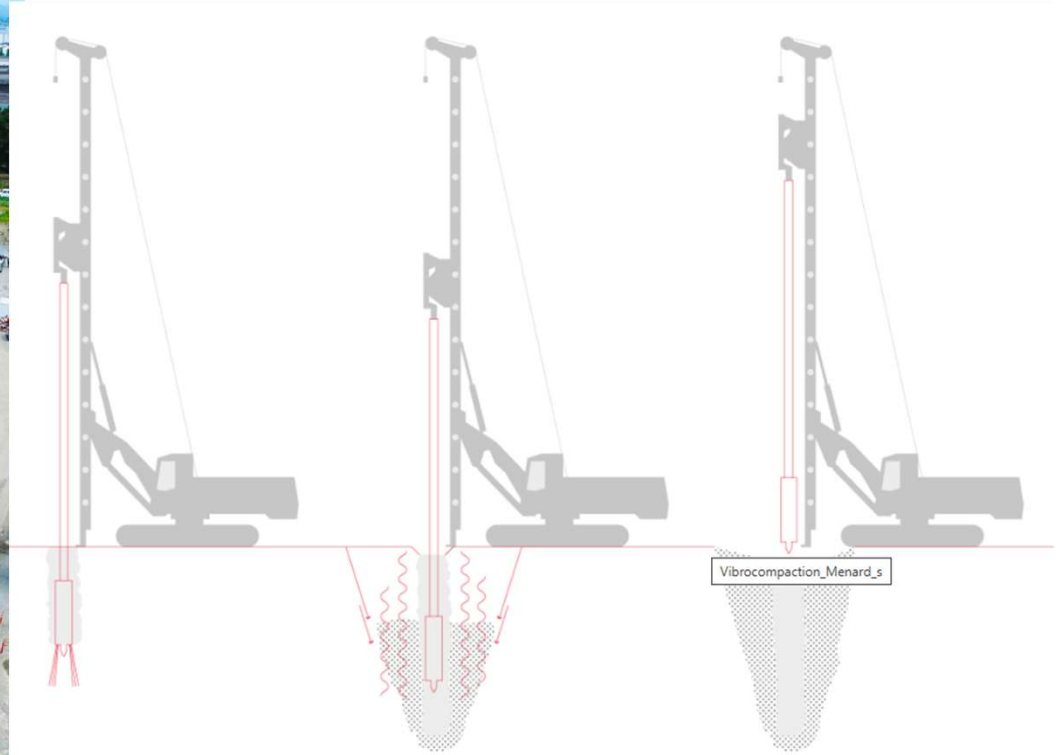
VIBRO COMPACTION

- **LOOSE OR VOIDED SOILS**
- **VIBRO COMPACTION**
 - By inserting a vibrating poker into the ground
- **DYNAMIC COMPACTION**
 - Dropping heavy weights
 - Using a heavy roller
- **GROUTING**
 - Injecting a sand/cement/bentonite mixture under pressure
 - Chemical grout

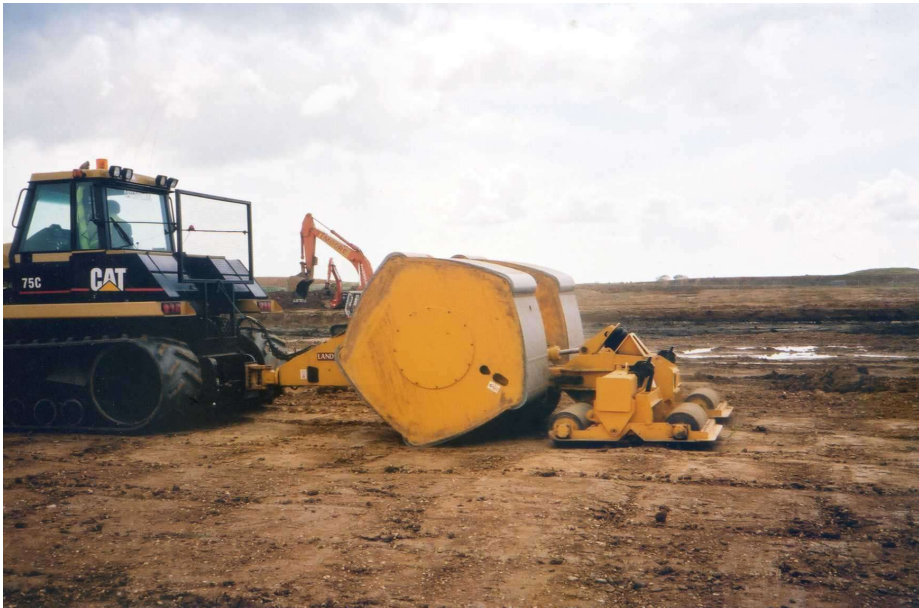
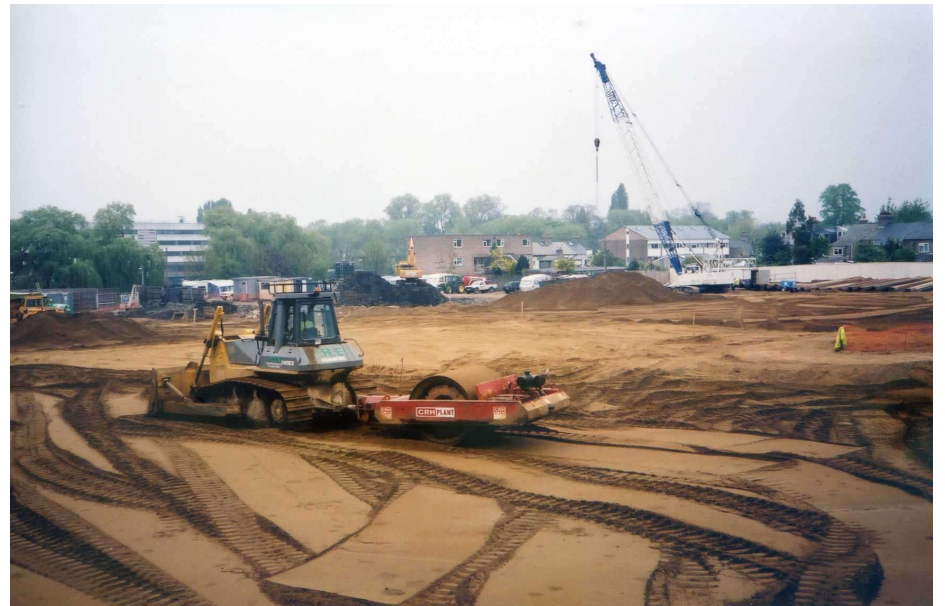
DYNAMIC COMPACTION (2)

BOTH SITES WERE FORMER LANDFILLS
